**15000 Main Street
City, State, zip code**

SUMMARY OF DEFICIENCIES

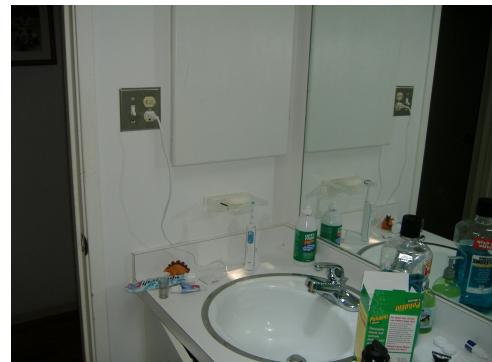
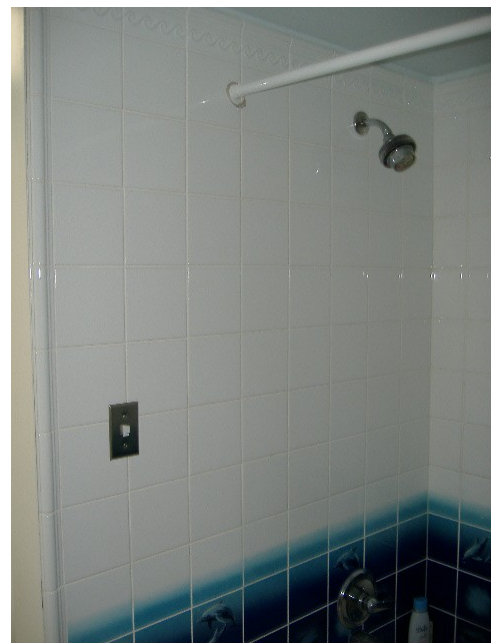
Bathroom 2 (Main Floor hallway)

- Fan: one, operational
- Floor material: ceramic tile
- Cabinet types: laminated
- Cabinet top: laminated
- Shower/tub surrounding: ceramic tiles
- Tub type: built in
- Toilet: operational
- Receptacles: Receptacle near the sink is not GFCI! Must be replaced.

[All electrical outlets within 6 feet of bathroom, kitchen, and laundry sink shall be GFCI protected. NEC, Art. 210.8. GFCI protection is required NEC (210-8(a)(1))]

Switch: the light switch reachable from the shower/tub must be moved away.

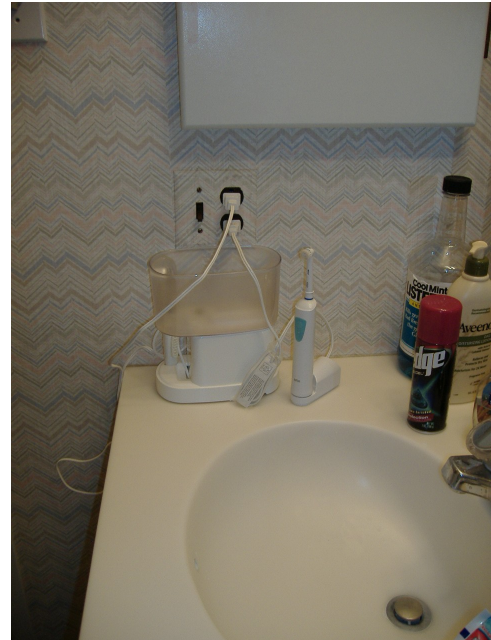
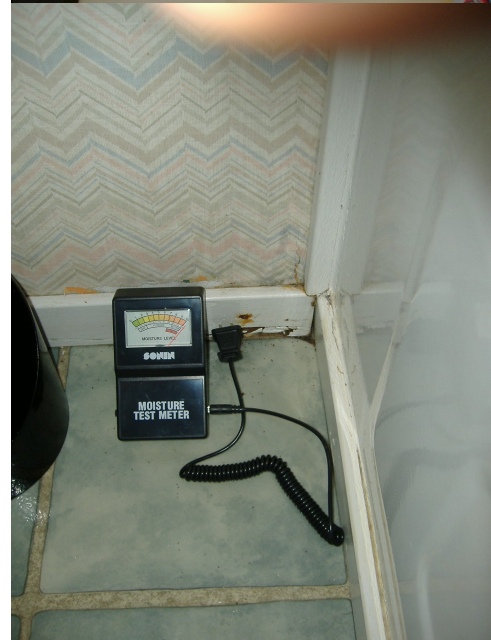
Bathroom 3 (Basement hallway)

Fan: one, operational
Floor material: ceramic tile
Cabinet types: laminated
Cabinet top: Plastic
Shower/tub surrounding: Plastic
Tub type: built in
Toilet: operational
Receptacles: Receptacle near the sink is not GFCI! Must be replaced.

[All electrical outlets within 6 feet of bathroom, kitchen, and laundry sink shall be GFIC protected. NEC, Art. 210.8. GFCI protection is required NEC (210-8(a)(1)]

Plinth behind the toilet and plinth on the base of the tub are rotten and must be replaced.
